## Site Specific Landfill Risk Assessment, Plan 704 ET, Mayerthorpe, Alberta

Prepared for the Town of Mayerthorpe/Lac Ste Anne County

**MMM GROUP**  
October 2007 | 07-4588.2-REP-01

**November 2007  
07-4588.2-REP-01**

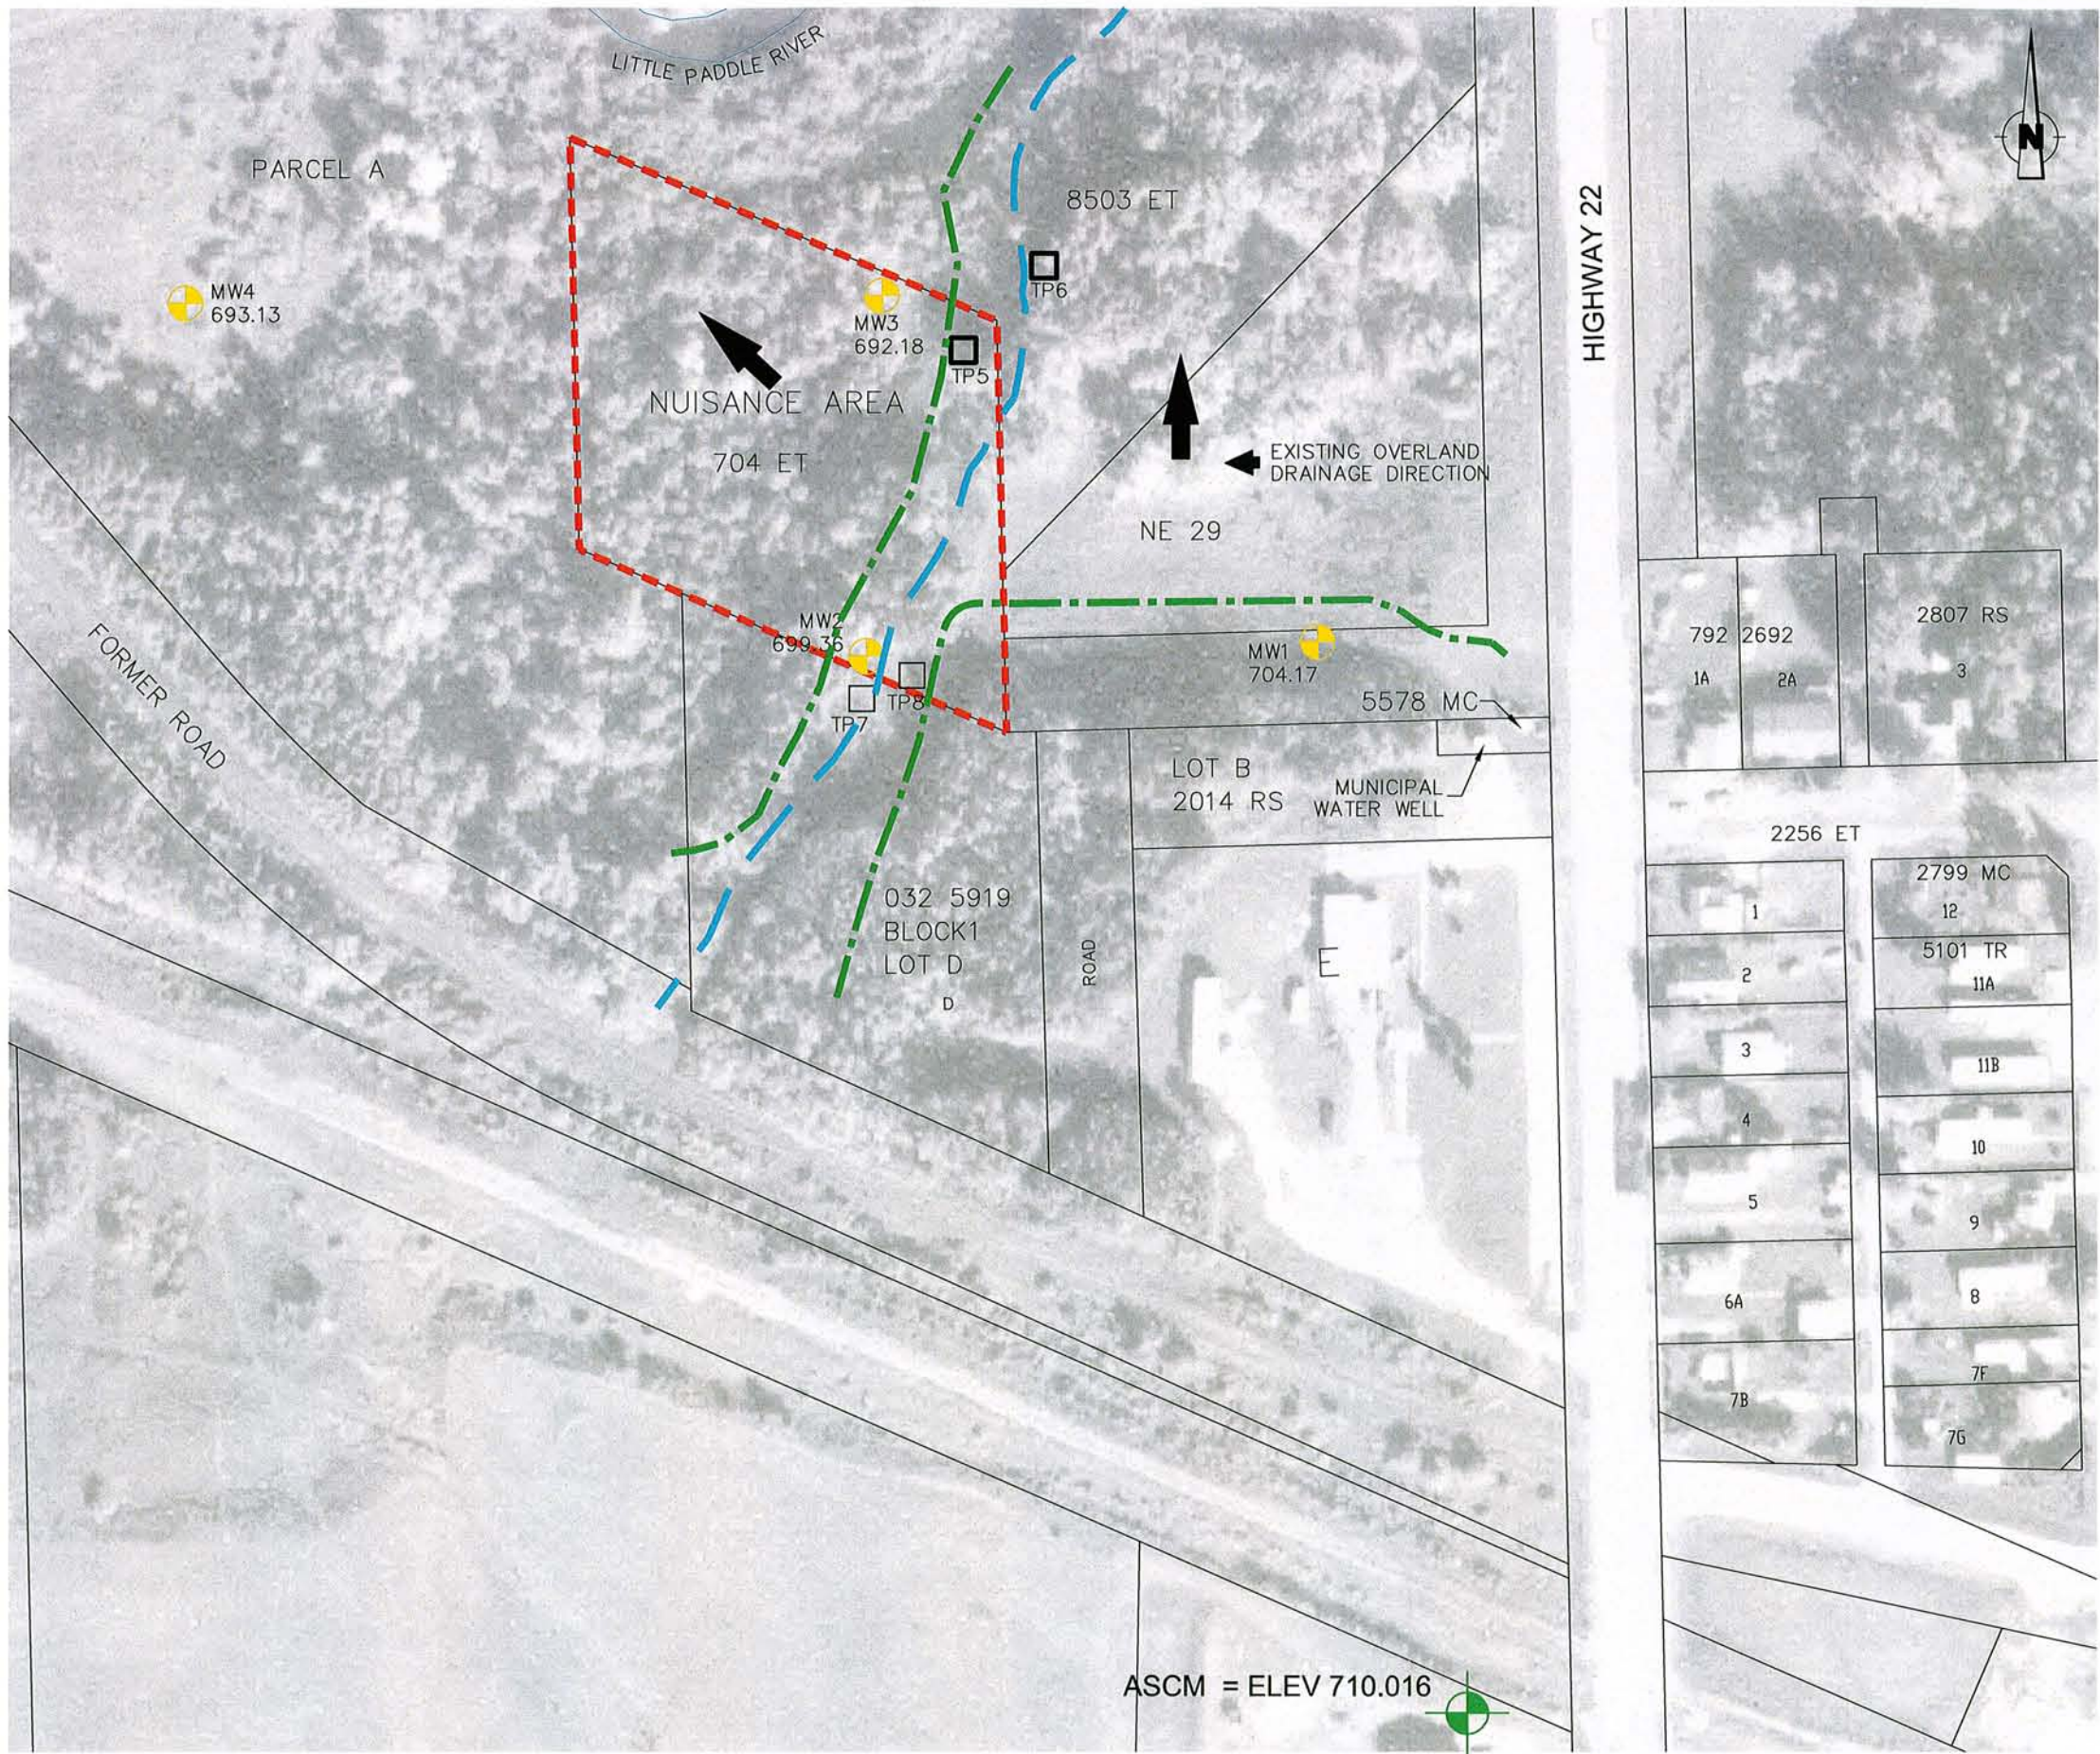
**FIGURE 2.1**

Four test pits (TP-5 to TP-8) were excavated by backhoe on September 19<sup>th</sup>, 2007, in areas of visible debris and in the general vicinity of the surveyed landfill area. The locations are shown on **Figure 2.1**. The test pit observations are as follows:

TP-5 – located SE of MW3; part way down embankment

- ▶ Roots top 0.5 m then dark brown silty clay
- ▶ Area 3m x 3m, depth 1.5 m
- ▶ Soil matrix contained glass, bones, pottery, brick, bottles and scrap metal debris below 0.5 m deep

TP-6 – located just east of a trail, downslope of the surveyed area

- ▶ roots and topsoil top 0.6 metres then dark brown silty clay
- ▶ area 4m x 4m x 2m deep
- ▶ bricks, pottery, glass, bones and scrap metal below 0.5 m deep

TP-7 – located 5 m south of MW2

- ▶ roots and topsoil to 0.5 m deep then brown sandy silty clay
- ▶ area 1.5 m x 2 m x 2 m deep
- ▶ soil matrix contained glass, bottles, jars, metal, tin cans, light bulbs, pill containers below 0.5 m deep

TP-8 – located NE of MW2

- ▶ roots and topsoil to 0.25 m deep then high plastic brown silty clay which turned brown below 0.75 m
- ▶ area 4m x 5m x 1.75 m deep

▶ no refuse or debris observed

TP-7 contained the most debris followed by TP-5, TP-6 and no debris in TP-8. There was no evidence of organic matter with the exception of plant roots and some large (beef) bones.
